DRAFT TECHNICAL MEMORANDUM

TO: Lynda Deschambault, U.S. EPA
FROM: Mike Johnson, P.E.
SUBJECT: December 2, 2016 - Field Observations
DATE: December 6, 2016

Introduction

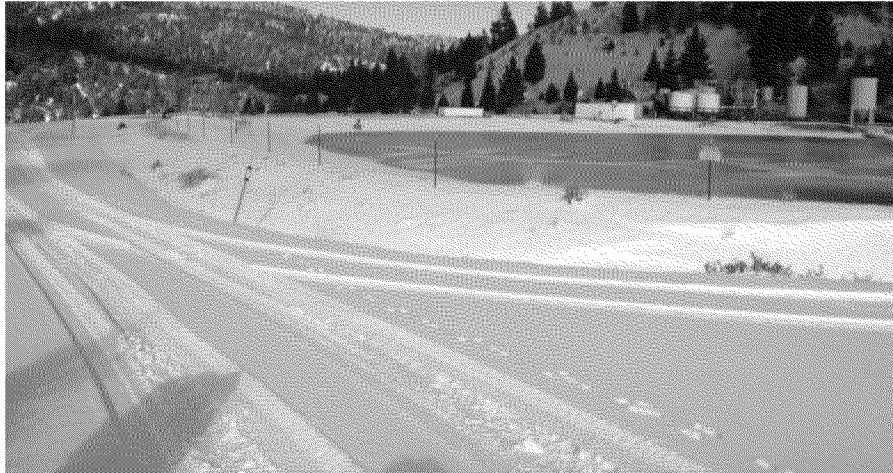
Photograph 1: Pond 1

The pond water levels in Pond 1, Pond 2S, Pond 2N, Pond 3, and Pond 4 were all well below the overflow structures as seen in the Photographs 1 through 5.

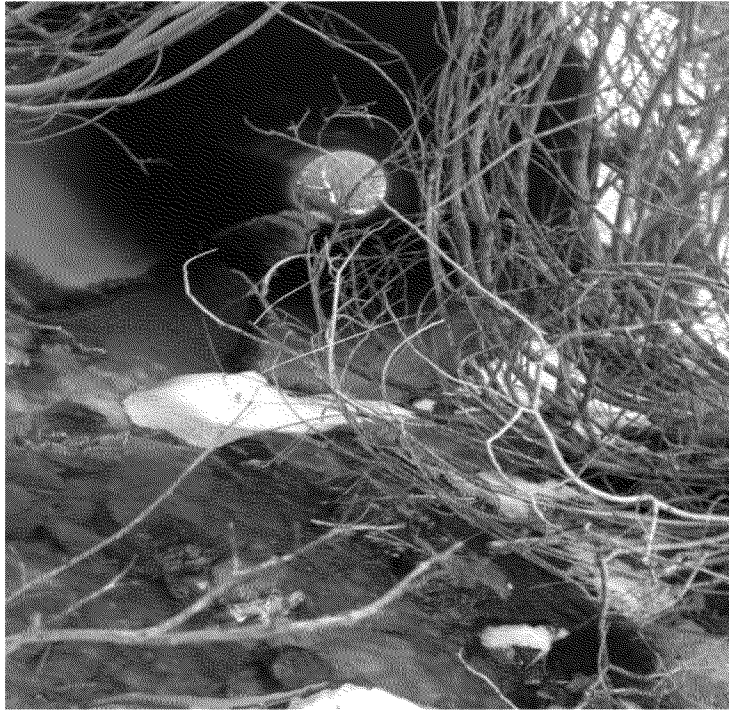
Field observations of the Leviathan Creek culvert downstream of the beaver dam / beaver pond complex were conducted to determine if there was indication of beaver dam failure . Field staff did not observe any debris restricting flow or any indication of beaver dam failure as seen in Photographs 6 and 7.

Photograph 6: Leviathan Creek Culvert Looking Downstream

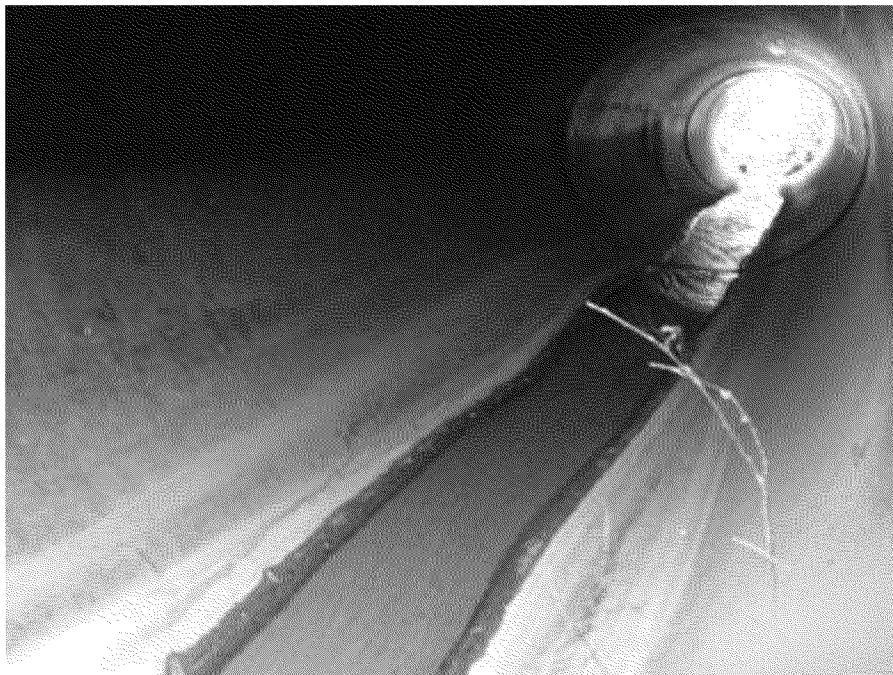
Photograph 7: Outfall of Leviathan Creek Culvert
